Christian Valley Park CSD Water Report – May 2021 (Preliminary Submittal – 6/11/2021)

Storage Tank Project Update

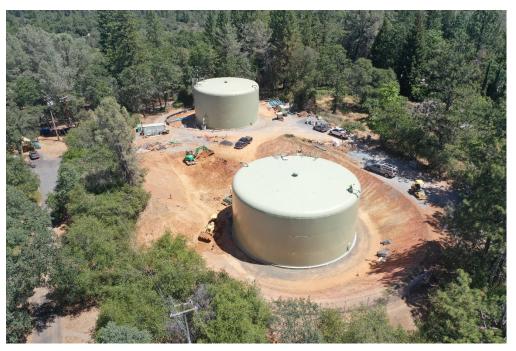
Tank 2 in foreground

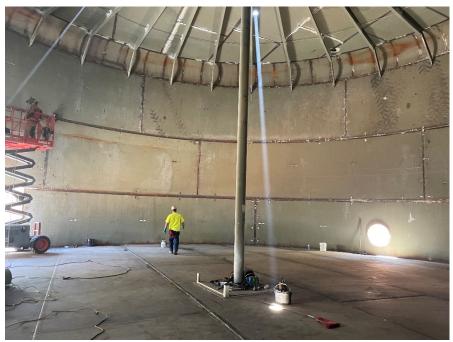
Interior of Tank 2 prior to coating – green color is the zinc primer

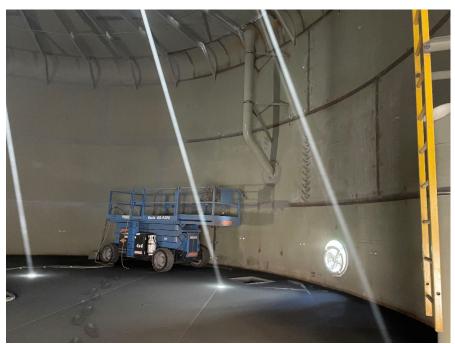
Interior of Tank 2 - Sand blasting and prepping for stripe coat

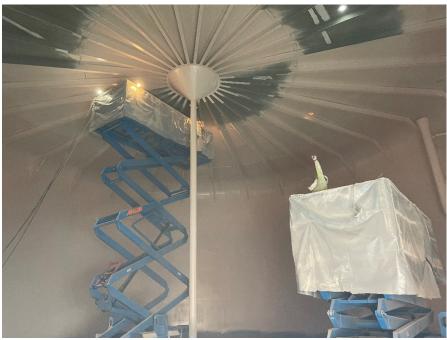
Intermediate coat - note pink tint to distinguish from top coat (white)

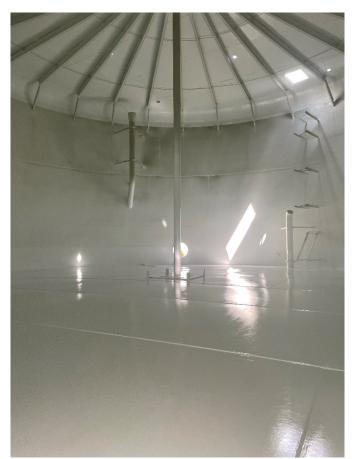
Top coat - white

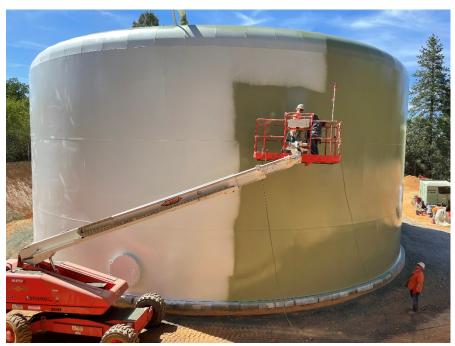
Exterior painting - top coat (green) over intermediate coat (white)
